The RCA 4-A-1 Condenser Microphone

John Staples, W6BM

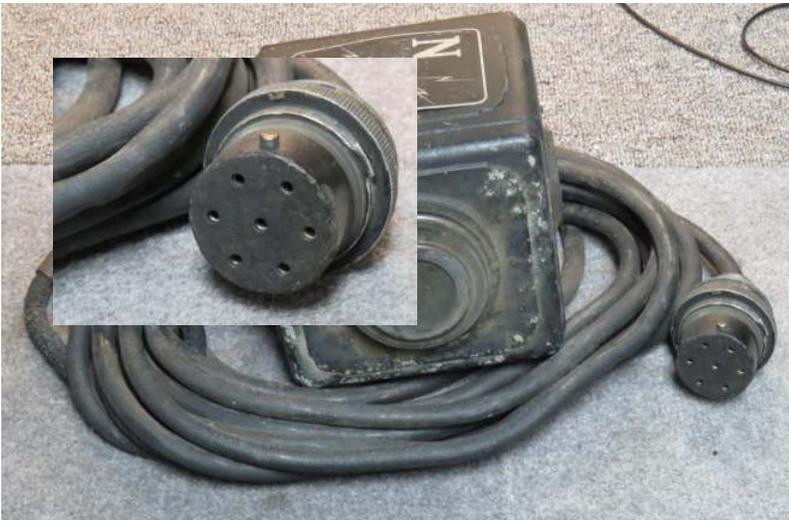
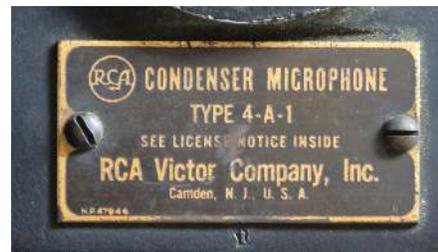
The back of the microphone that faces the audience shows the NBC logo over a USA map and an electrified microphone logo. The NBC logo is displayed diagonally on each side.

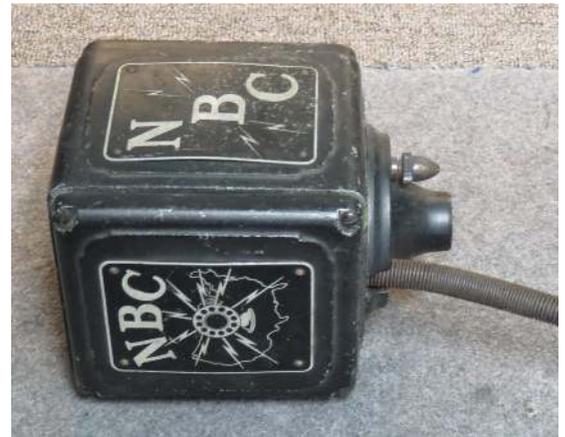
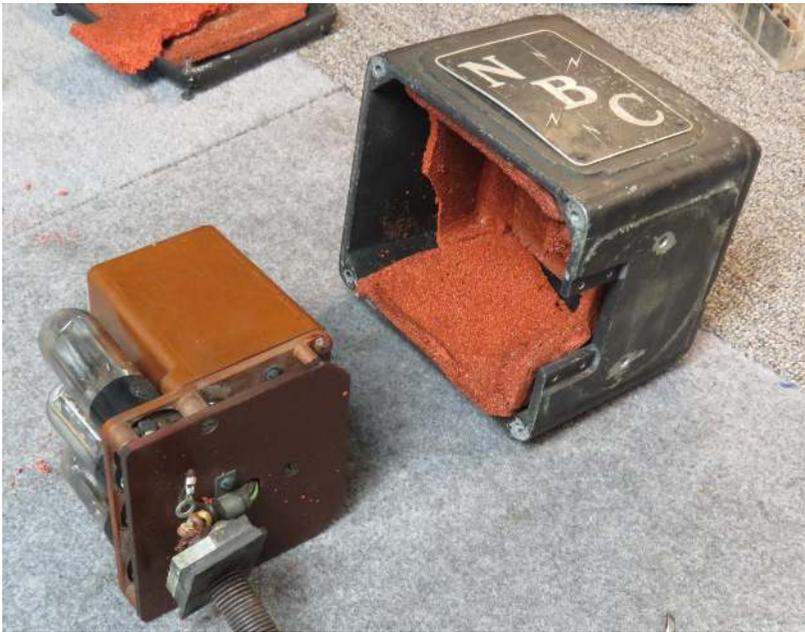
Inside the microphone body, a three-tube amplifier converts the very small voltage from the condenser element to a stronger signal on the output terminals. The amplifier is contained within a foam vibration and acoustic barrier, which has hardened in time but still fairly intact.

Looking inside the compartment, the back of the condenser element is seen. The condenser element consists of a backplate with a thin stretched diaphragm closely spaced in front of it that the sound wave causes to vibrate.

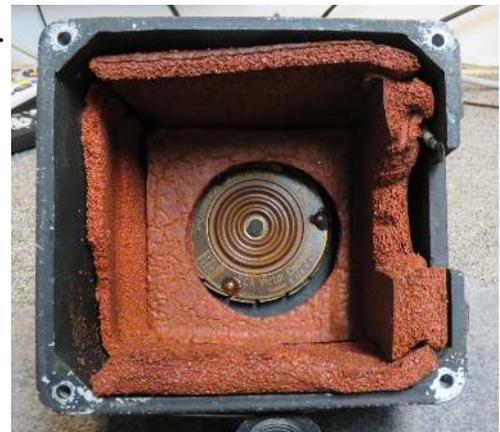
Inside the enclosing cap of the amplifier module are the passive components. There are four large mica capacitors, used as interstage coupling and power supply bypass, several large resistors in

the Megohm range, and two large 150 Kohm resistors with metallic caps which are the plate resistors for the first two stages. An output transformer is in the plate circuit of the third amplifier stage that provides the audio output with taps for 250 and 500 ohm impedance. Only the 250 ohm output is brought out to the interface cable.

As received, the 150K plate load resistor in the second stage was open, and all the capacitors are leaky in the 100 Megohm range, with the 0.01 uF input coupling capacitor in the 1000 Megohm range. The unit may work with the present capacitors, but the open 150Kohm resistor must be replaced. All the tubes show good filament continuity and measure with a transconductance of 700 micromho with a Weston 686 industrial tube tester, but the pins need cleaning. The power supply must provide 6 volts at 0.25 A for the filaments, and 90 and 180 well-filtered DC voltage for the amplifier stages.

The amplifier section was checked out with an external signal drive and found to be fully operational, once the open 150 Kohm resistor in the plate circuit of the second stage was replaced with a metal-film resistor. All other components were found to be good enough to be operational, in particular the input blocking capacitor from the microphone element to the grid of the first stage had a leakage resistance of 1000 Megohms. Operating the microphone at a reduced voltage of 40 volts on the first and second stage and 80 volts polarizing voltage on the condenser element and output stage would not result in upsetting the bias voltages on the tubes significantly.

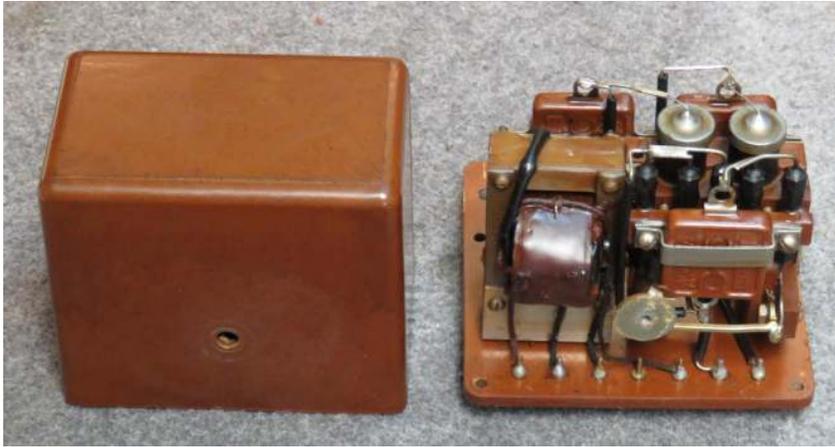
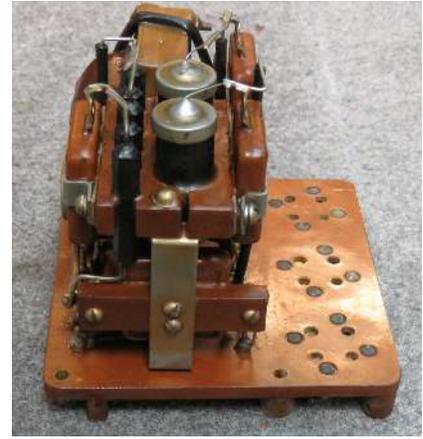
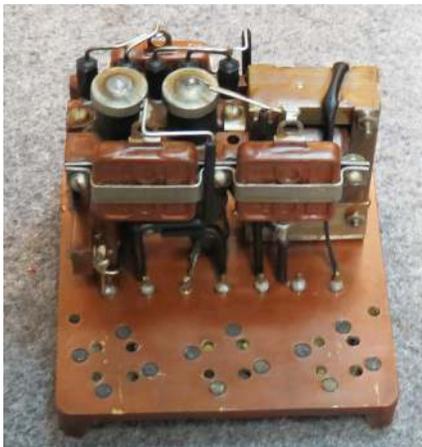
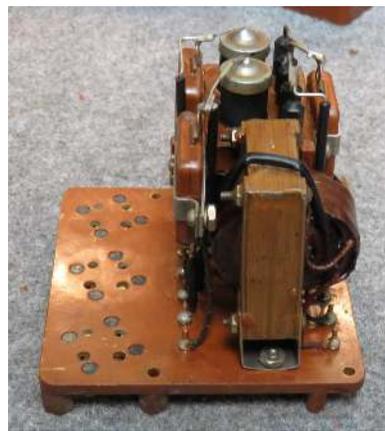
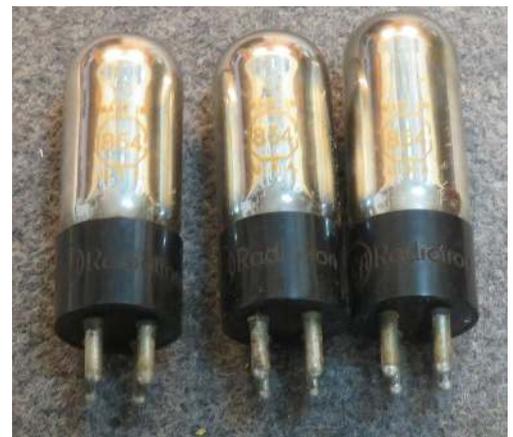
RCA 4-A-1 Capacitor Microphone

The schematic was drawn from tracing the conductors in the microphone itself. The resistance and capacitance values are indicated on the parts, and the operating voltages are etched onto the supporting structure.

The pin-outs on the connector were sounded out from the connector itself to their destination on the wiring board. The wires are color-coded.

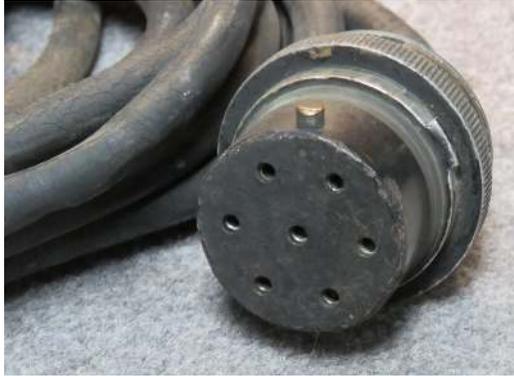
The microphone with its power cord, as received is in moderate and somewhat dirty condition.

The long power cord is terminated at one end by the microphone with a spring sheath that reduces bending of the cable and at the other end of a large 7-pin connector.

The 7-pin connector pinout, according to the original RCA numbering scheme, is shown below.

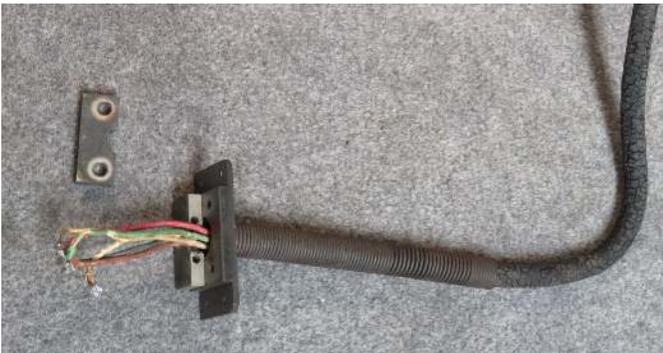
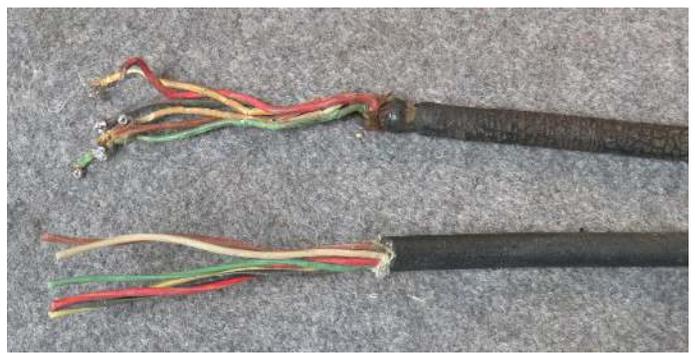
The jacket of the first three feet of the power cord is in poor condition and the rubber-insulated wires exposed at the end are cracked.

The first three feet of the power cord is removed and the insulation stripped back to expose the six wires. The power cord is constructed for long service as under the rubber outer layer, a woven steel shield protects the enclosed wires. The rubber-covered wires exposed were in good condition and re-attached to the circuit board.

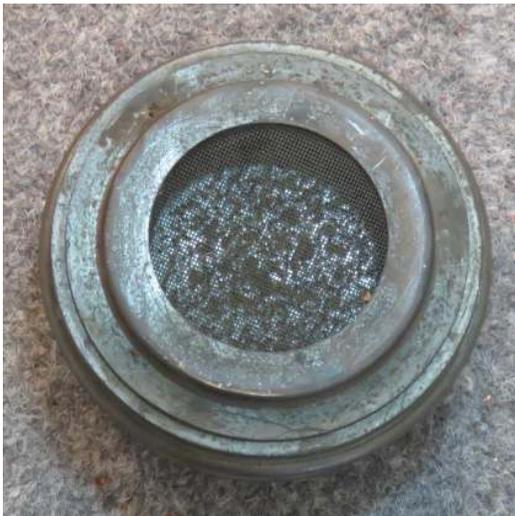
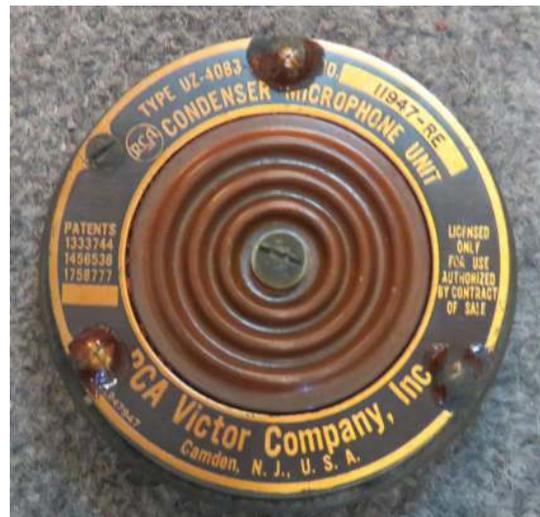
The condenser microphone cartridge condition was then assessed. Unfortunately, the condenser microphone was non-operational. Looking through the mesh grille, the diaphragm exhibited a mottled appearance.

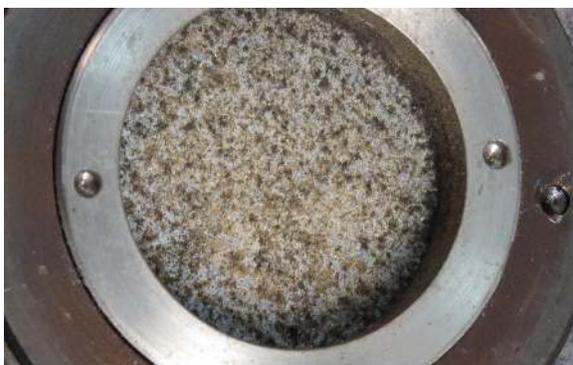
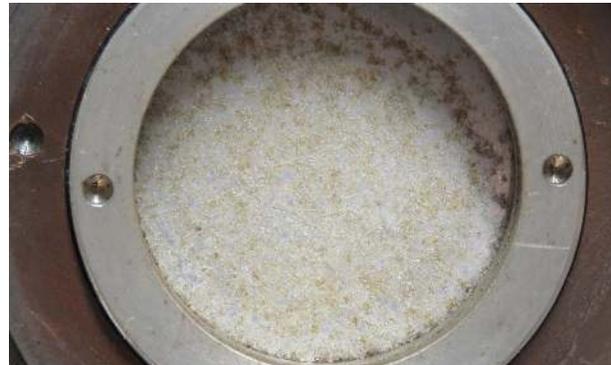
After the grille was unscrewed to get a better look, the diaphragm appears to be covered with dirt. The dirt was carefully rinsed away with cotton swabs and water.

The diaphragm was found to be short-circuited to the back (ground) plane. The cleaning produced a temporary open-circuit, but the diaphragm would soon again short-circuit.

An attempt was made to remove the short by a controlled low-energy discharge from a charged capacitor across the terminals. This had the effect of partially removing the short, with resistance values sometime increasing to 100 Megohms with 50 volts across the terminals. The capacitance between the diaphragm and the backplate measured to be 130 pFarads.

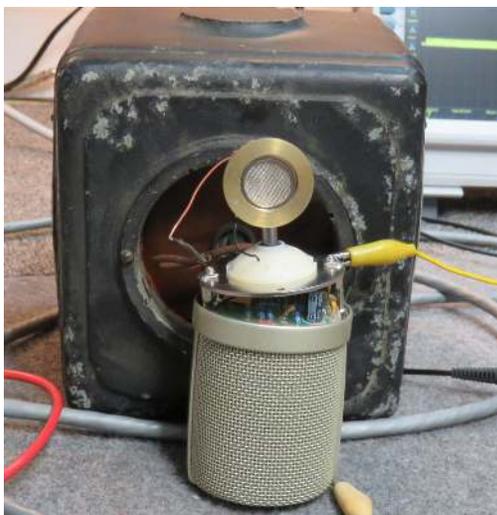
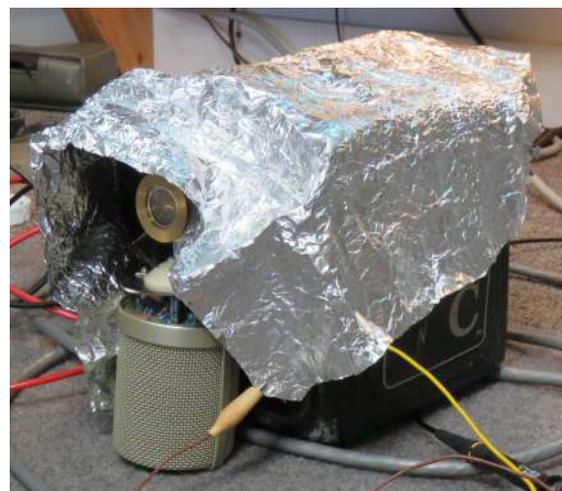
To determine the noise level of the amplifier, a condenser element of a modern MXL-brand microphone was substituted for the RCA cartridge.

The diameter of the MXL diaphragm is 20 mm: the RCA diaphragm diameter is 40 mm, so the MXL area is one-quarter of the RCA. If the spacing between the diaphragm and backplate is the same, the MXL would give roughly one-quarter the output for the same polarizing voltage.

The speaking tests showed a very clear and low-noise output with the MXL cartridge. No quantitative measurements were made of the signal-to-noise level, but the performance was quite satisfactory, showing that the amplifier in its current condition is capable of good performance. And this was made at an 80 volt polarizing voltage, below the default 180 volts for the RCA cartridge.

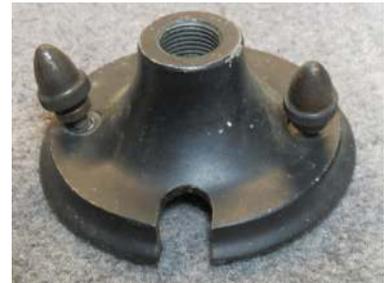
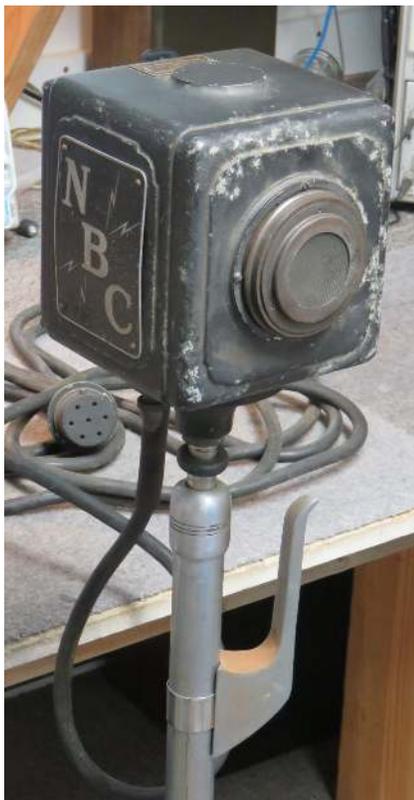
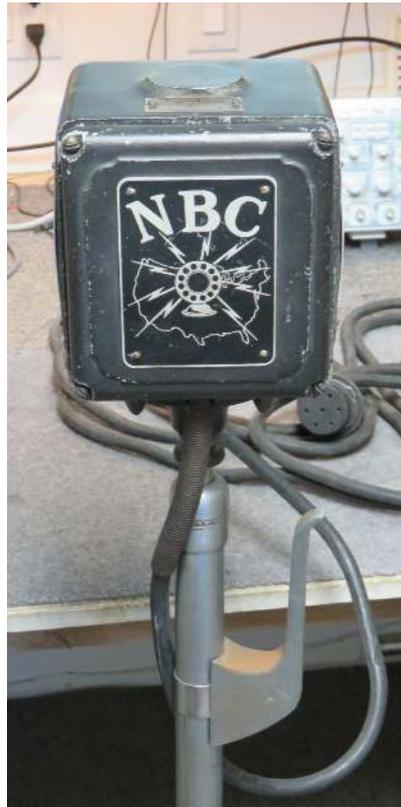
The microphone was reassembled with the stand interface which is threaded with a half-inch pipe thread microphone stand connector. The connector is detachable from the microphone with two acorn-shaped screws.
